Michael J. Calaway
Jacobs Technology
at NASA Johnson Space Center

GENESIS Journeyed to Earth-Sun Lagrange 1

Genesis capturing the sun: Solar wind irradiation at Lagrange 1

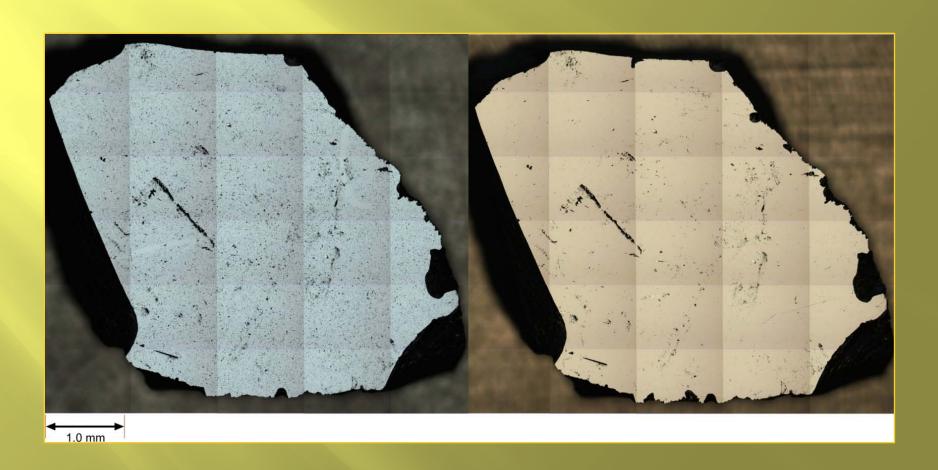
Genesis Si B/C array sample 60458

Before and After UPW/Megasonic Cleaning

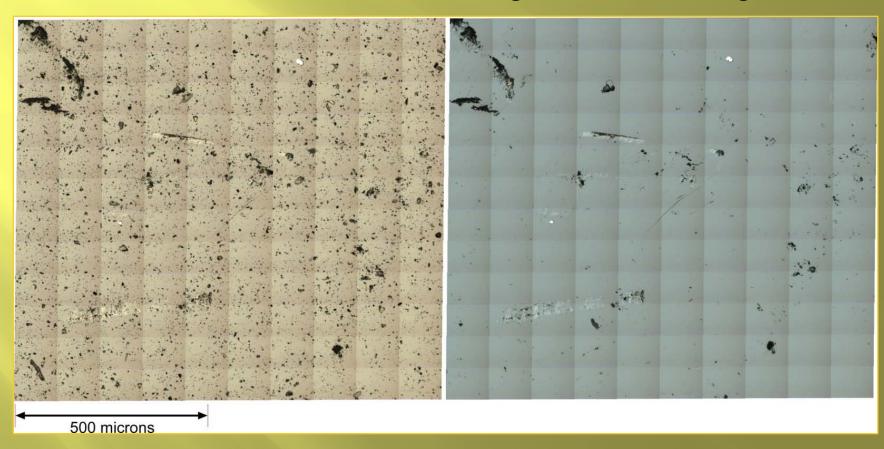
Genesis Si B/C array sample 60458

Before and After UPW/Megasonic Cleaning

Taken with Leica DM 6000 M Optical Microscope with 50X lens

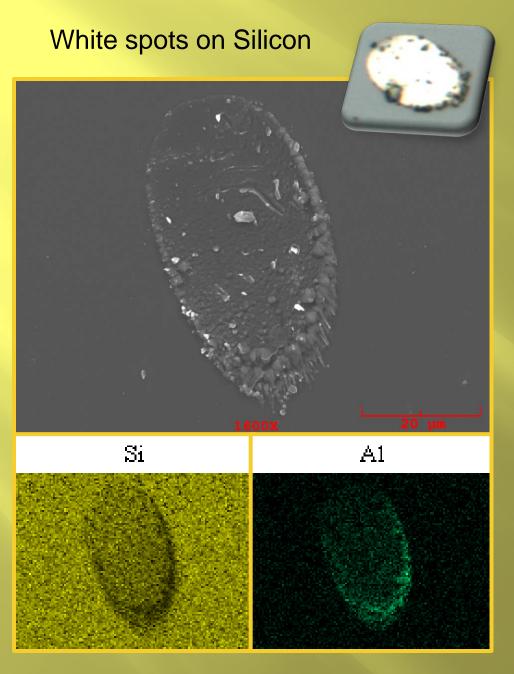
Possible Contamination Source?

Al-arc spray on the C-C ablator

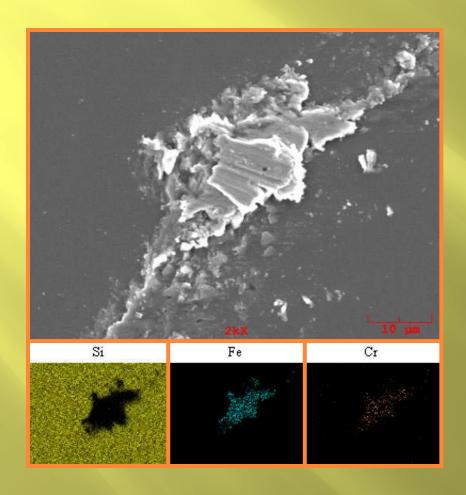
Stainless Steel Contamination

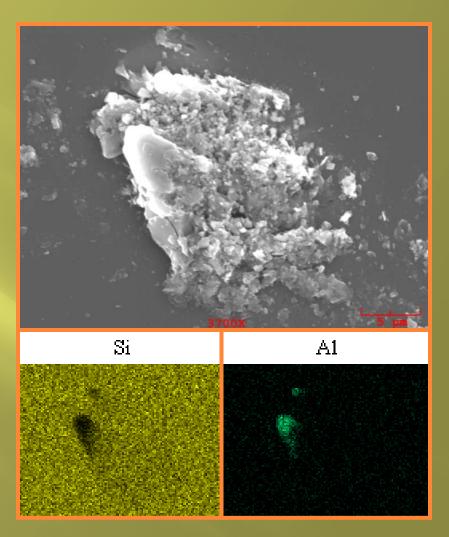
Pure Aluminum Contamination

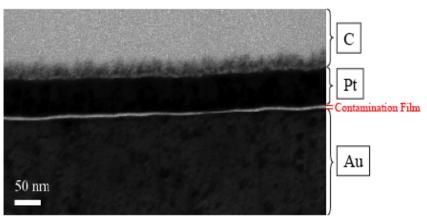
Bright-field micrograph of the FIB lift-out membrane

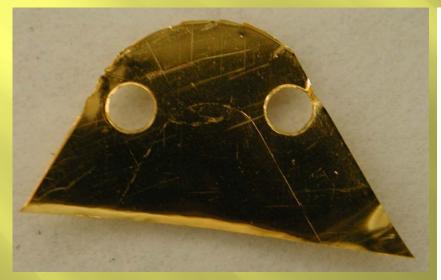
The Famous Brown Stain Visible on the Gold Foil

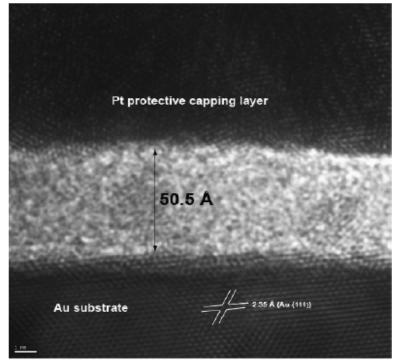
HRTEM micrograph showing the contamination film between the Pt protective capped layer and the Genesis Au-foil. Thickness of the contamination film is 50.5 Å.

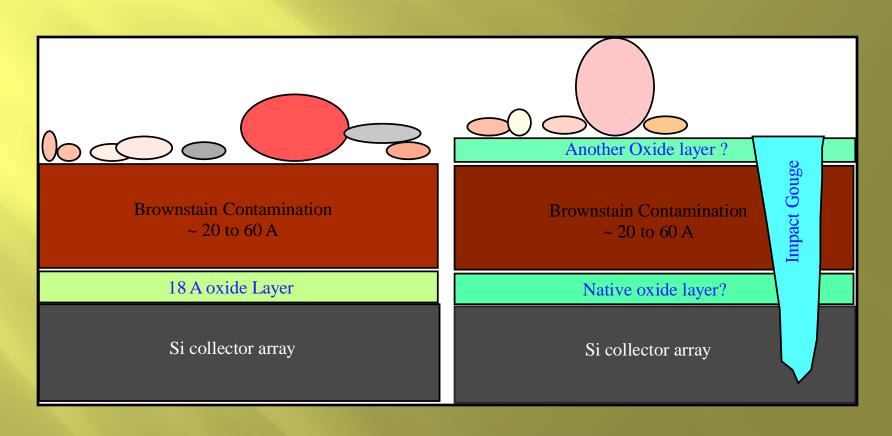
Sample 60208 Flown Genesis Si B/C array

If Brown Stain Existed: Two possible Ellipsometry Models (2005-2006)

2 cauchy	0.00 Å
1 sio2_jaw	36.14 Å
0 si_jaw	1 mm

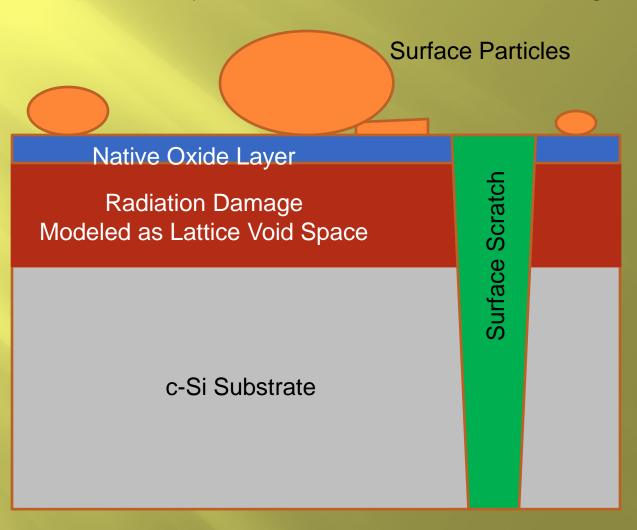
Sample 60208 Flown Genesis Si B/C array

If Brown Stain was not present: Ellipsometry Model for Radiation Damage

2 sio2_jaw	34.55 Å
1 EMA (si_jaw)/1.24% void	609.85 Å
0 si_jaw	1 mm

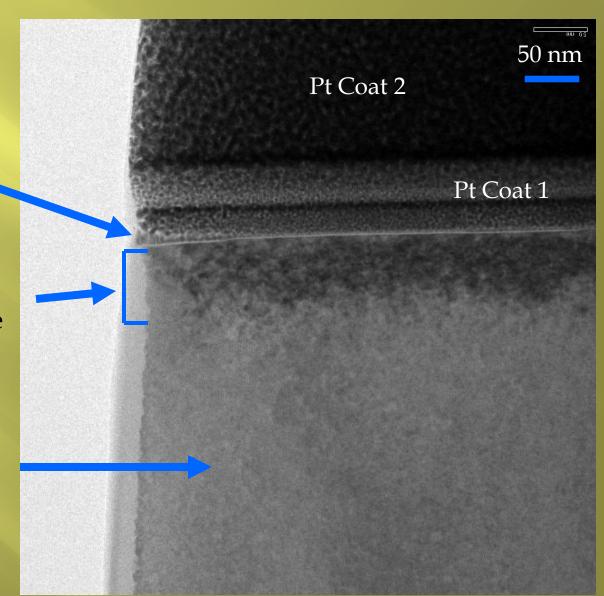
JEOL JEM 2500SE STEM Image of 60208.1 Si B/C Array

Wafer Surface Native Oxide Layer $SiO_2 = \sim 38 \text{ Å}$

Complex Diffraction Contrast Radiation Damage Zone Depth = $\sim 610 \text{ Å}$ Range = 60 - 75 nm

Crystalline Si Substrate

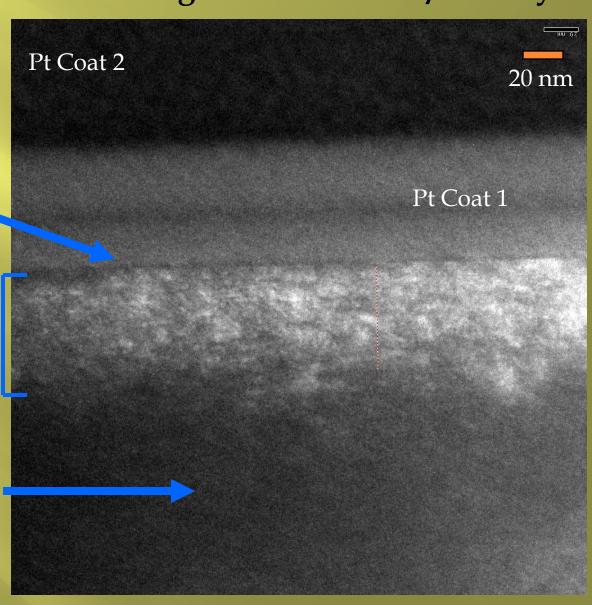
STEM Image of 60208.1 Si B/C Array

Wafer Surface Native Oxide Layer $SiO_2 = \sim 38 \text{ Å}$

Complex Diffraction Contrast

Radiation Damage Zone Depth = $\sim 610 \text{ Å}$ Range = 60 - 70 nm

Crystalline Si Substrate

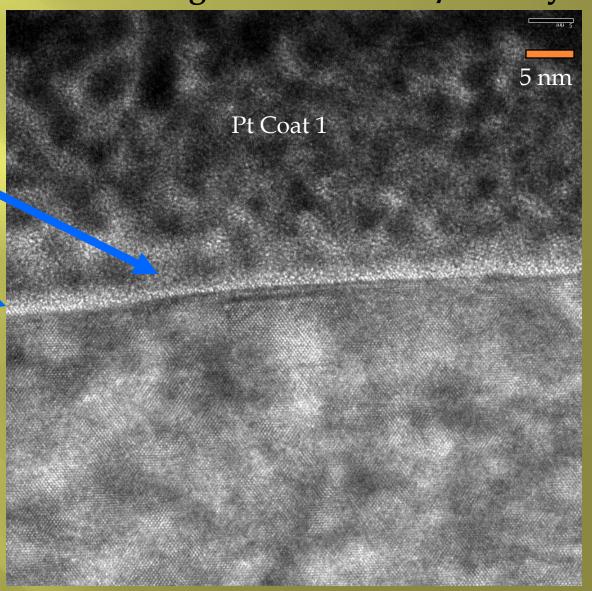
STEM Image of 60208.1 Si B/C Array

Wafer Surface

Native Oxide Layer $SiO_2 = \sim 38 \text{ Å}$

Radiation
Damage Zone

Arrows show possible stacking faults within the strained region directly below the native oxide layer.

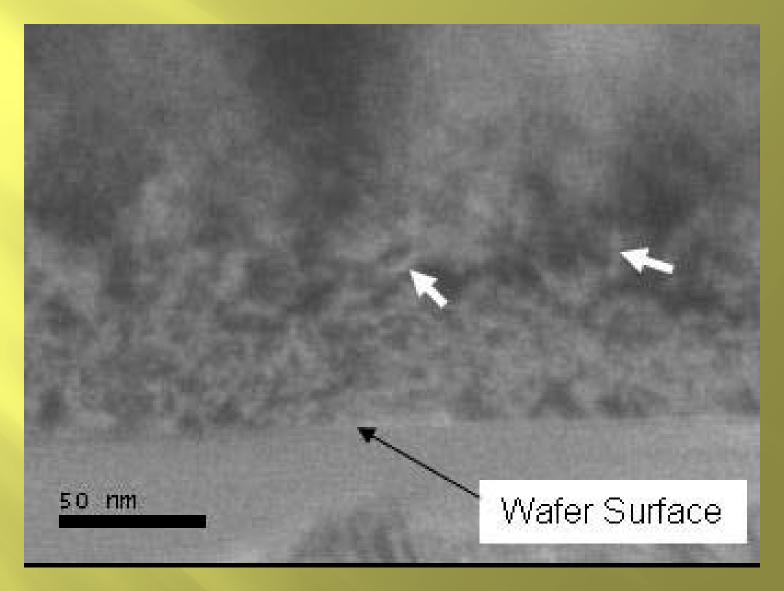
Arrows show possible dislocation line segments within the strained Region.

Arrows shows areas of possible dislocation loop defects within the strained region.

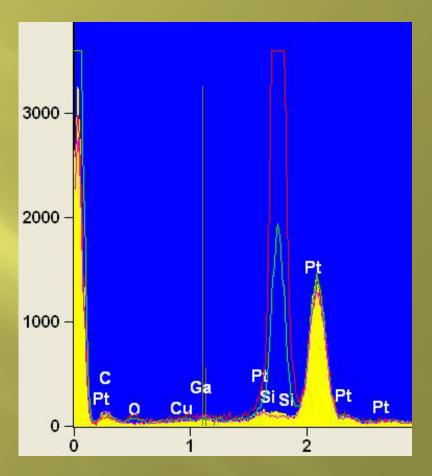
Brown Stain Search with a 1 nm EDS Spot

X-ray EDS spectrum of a 1.0 nm diameter probe transect analysis between the Si substrate and Pt coat. The spectrum clearly shows no change in the C/Pt ratio near the Pt to wafer interface.

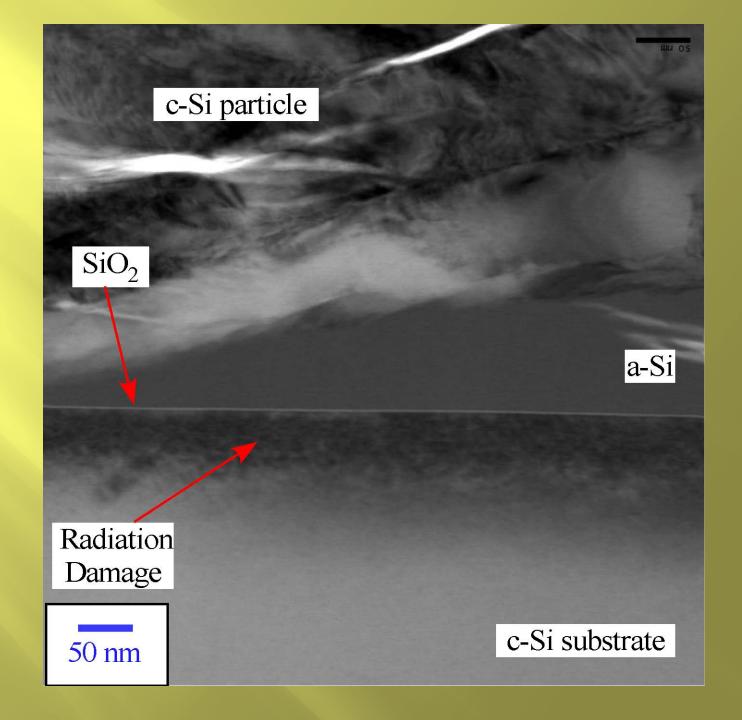
STEM Image of 60208.4 Si B/C Array

a-Si Particle on wafer surface

Wafer Surface Native Oxide Layer $SiO_2 = \sim 18 \text{ Å}$

Radiation / Damage Zone
